DRUG ALERT CLASS 4 no 2 2017 – Caution in Use

**Mirena 20 micrograms / 24 hours intrauterine
delivery system**

Batch Number	Expiry Date	Pack Size	First Distributed
TU01BPE	Jun 2019	1 x 1	29 Aug 2016

Information about an observed Insertion Tube Defect UK Batch TU01BPE

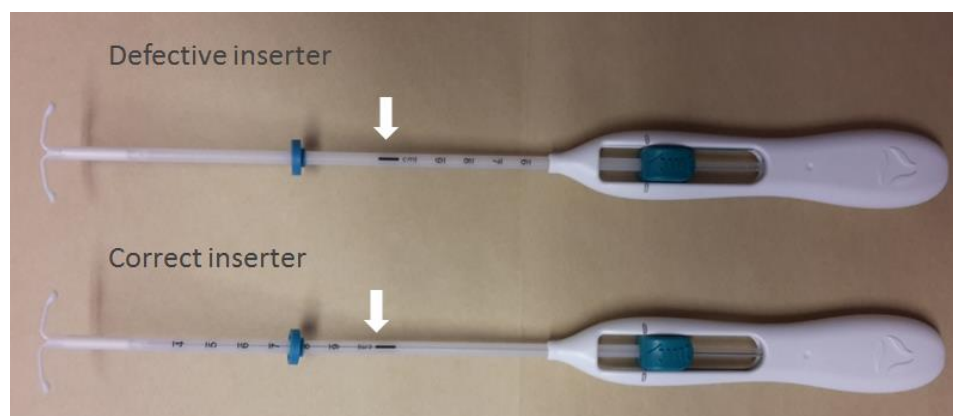
Any stock on hand from the above batch should be inspected to ensure that the insertion tube is mounted correctly. This can be done without opening the blister. The picture below shows correctly and incorrectly mounted inserters.

Bayer plc has informed us that they have received two complaints globally concerning Mirena inserters with an insertion tube which is mounted inversely to the handle. This has resulted in inversion of the insertion depth scale, which may lead to incorrect insertion depth and the possibility of a reduced efficacy or adverse events. A very small number of Mirena inserters may potentially be affected by this issue.

The "cm" scale should start at the tip of the insertion tube and increase towards the handle of the inserter.

Any incorrectly mounted insertion tubes identified should be reported to Bayer plc by telephone, 01635 563116 or by email, medical.information@bayer.co.uk

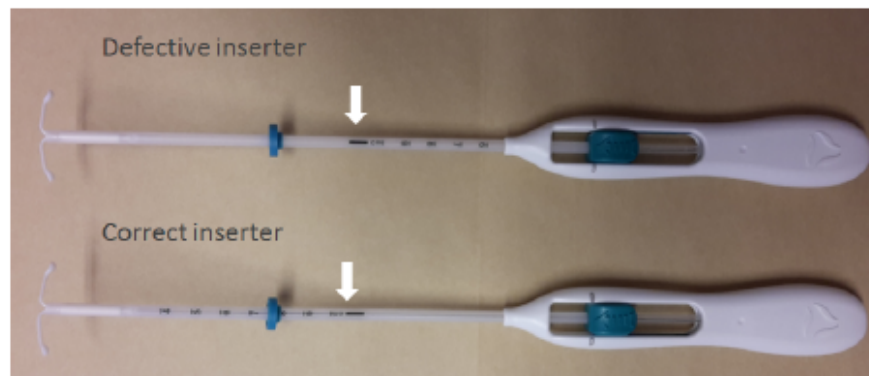
The insertion tube is mounted inversely to the inserter handle. This results in an incorrectly positioned and inverted appearing scale on the tube. Please refer to the picture below:

The "cm" scale should start at the tip of the insertion tube and increase towards the handle of the inserter.

Based on the current investigation, a very small number of inserters are affected. So far, only two such units have been identified globally.

Only use a Mirena with a correctly mounted insertion tube; please refer to picture above. Even though the chances that you will encounter an inserter with misplaced inserter tube and inverted scale are considered low, Bayer asks you to thoroughly check the inserter prior to use. If the inserter is found to be defective please contact the Medical Information department using the contact details below.
